MEAT MINCER ENTRAPMENT, MELBOURNE, AUSTRALIA

Monday, 20 June 2005

Incident number 4113 – 1831 hrs. - March 20th. 2005

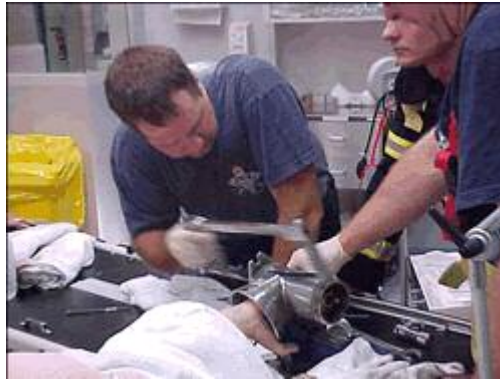
The initial cut enters the casing of the mincer.

Consequently, both fire-fighters took it in turns to use the hand hack saw to cut through the length of the cast iron casing, duration approximately 1½ hours. Extreme care had to be taken to ensure no further damage was done to the hand.

The Tigair saw was used for the areas well away from the hand. Many and varied options were put to us by hospital staff offering assistance, however, the only option we really had, was to use the hack saw.

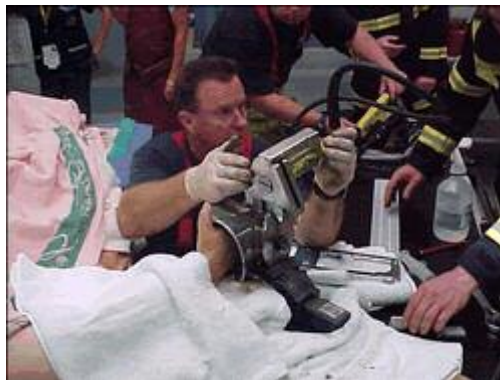
Rabbit tool being carefully applied after cuts to both sides of the casing and mounting plate.

After the casing was cut as much as we dared and as close as possible to the fingers, we experimented with various pieces of hydraulic equipment to crack the casing open.

Alligator jaws, the small combi-tool and finally a rabbit tool were delivered to us by P35.

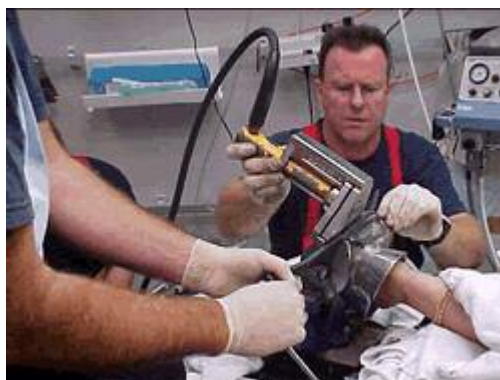
Jimmy bar being used to assist in splitting the casing of the mincer.

After placing the jimmy bar between the jaws we were able to push each side of the casing apart at the mounting bolt slots on the mounting flange of the mincer.

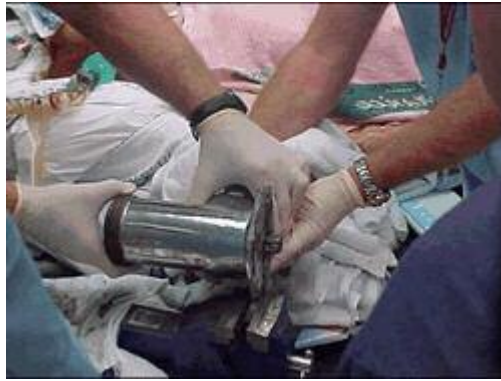
The split main casing, being carefully removed from the vice.

It opened up with a loud crack and the free casing and auger were easily removed.

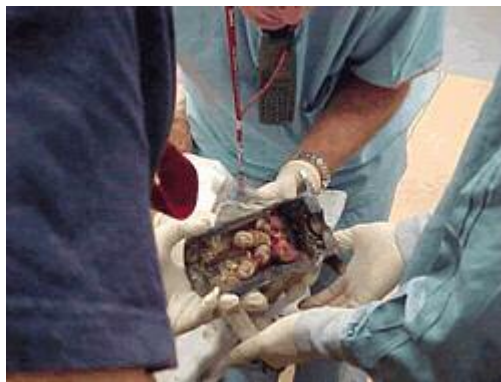
The casing open and injuries revealed.

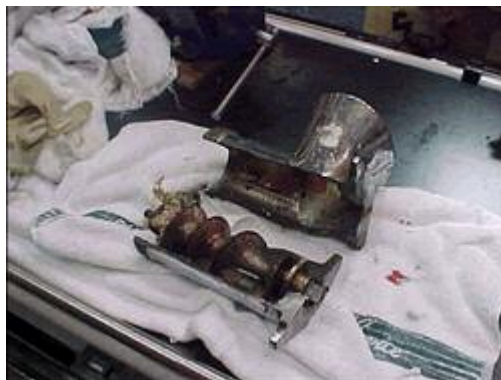
Cast iron casing revealing the auger and lower section.
